# UNDERWATER BRIDGE INSPECTION REPORT

STRUCTURE NO. 30501

CSAH NO. 7

RUM RIVER

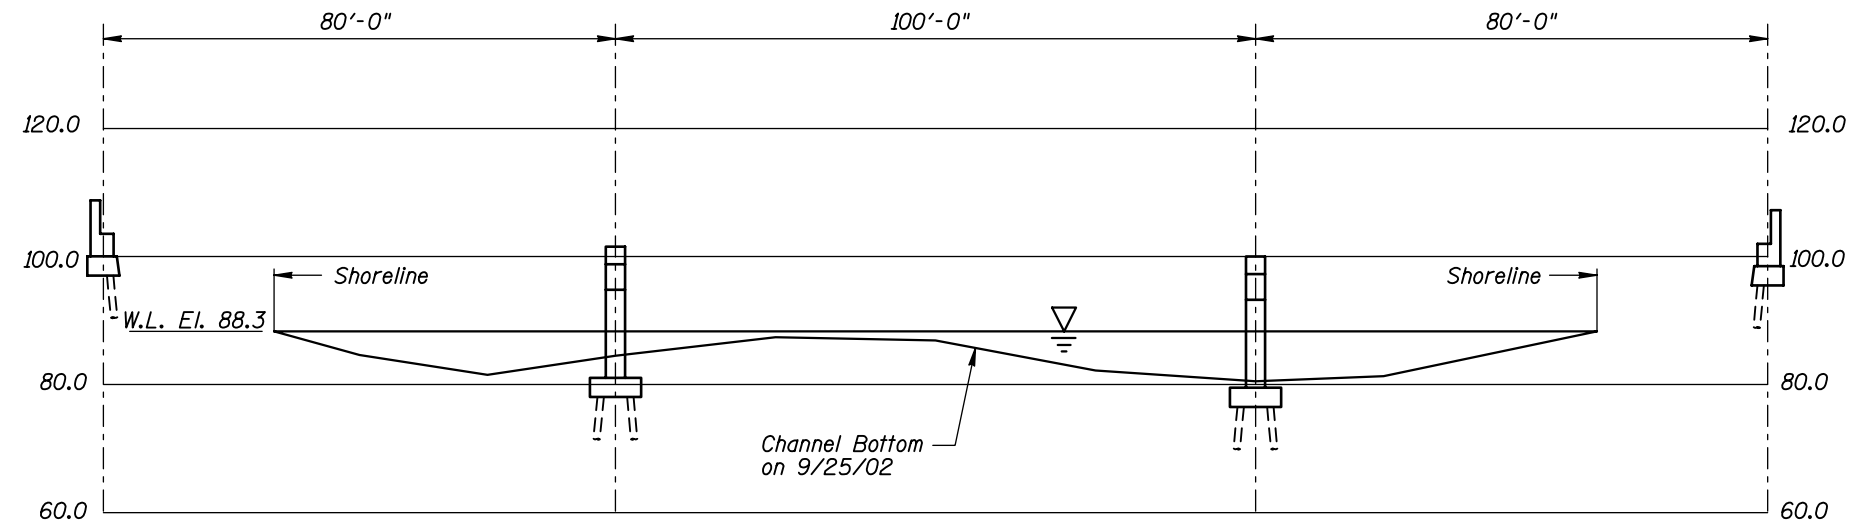
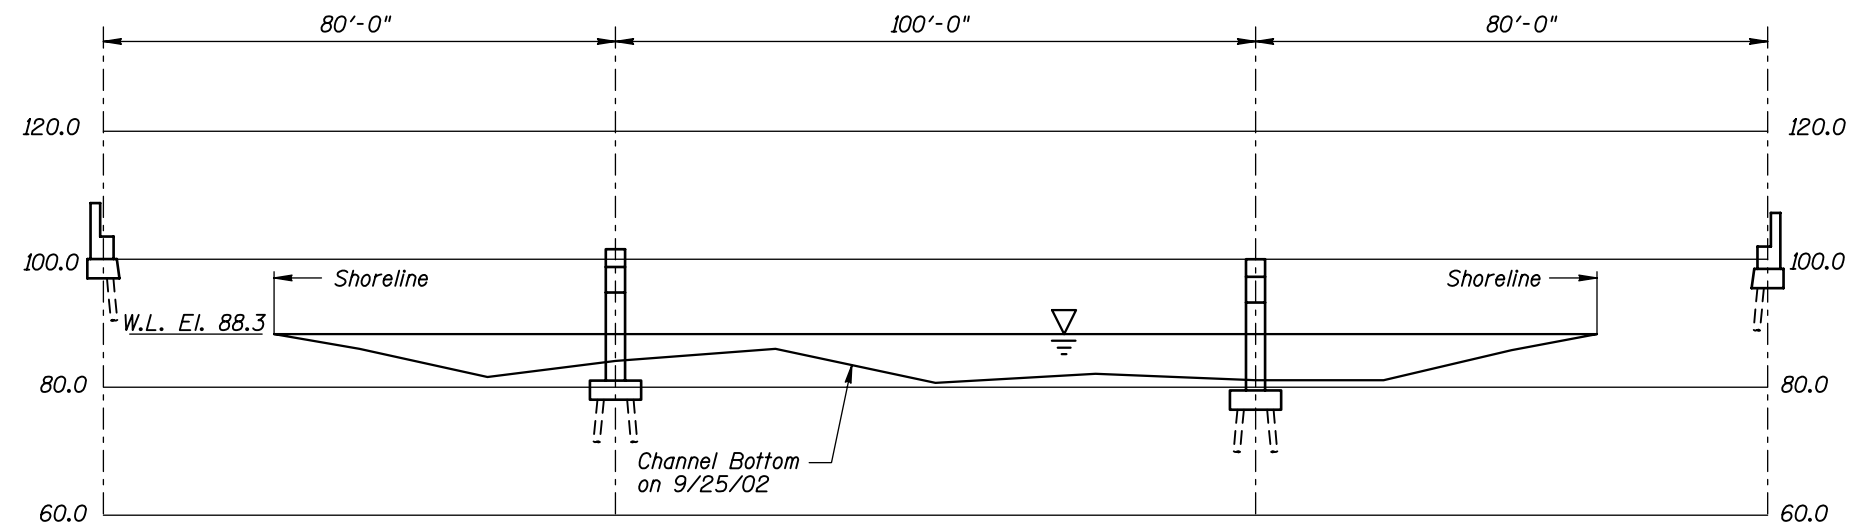
Figure No.: 2

**UPSTREAM AND DOWNSTREAM  
FASCIA PROFILES**

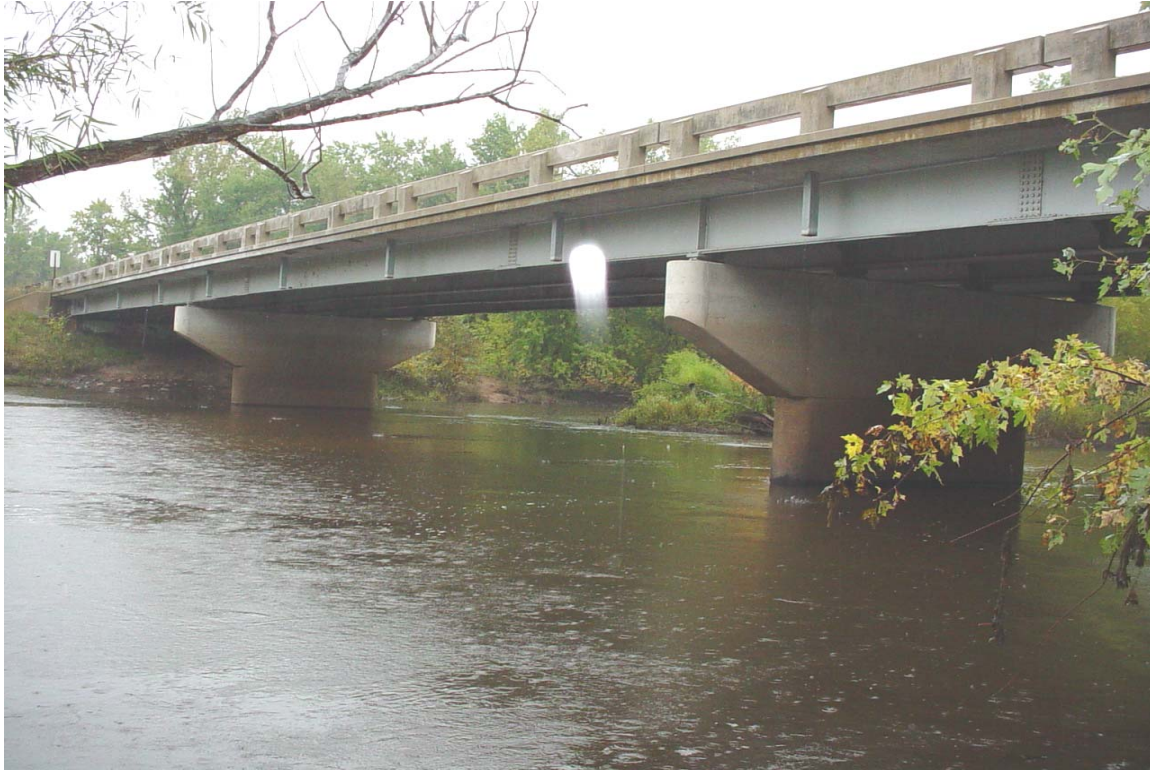
Photograph 1. Overall View of the Structure, Looking Northeast.

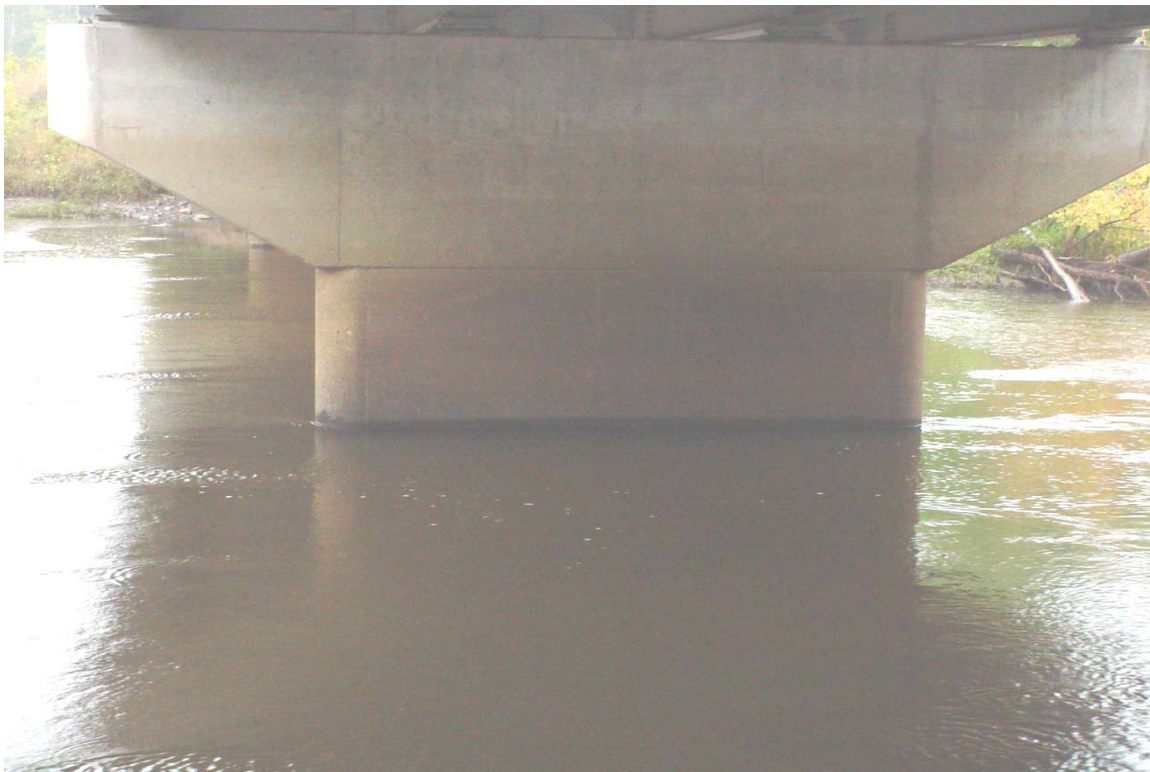
- (A) Light scaling with up to 1/8 inch maximum penetration was observed on the concrete pier shafts from the waterline to 4 feet below the waterline.
- (B) A minor scour depression, 2 foot in radius and 1 foot deep, was observed at the upstream nose of Pier 1.
- (C) A light accumulation of 2-inch-diameter-and-smaller timber debris was observed on the channel bottom at the upstream nose of Pier 1.

Photograph 2. View of Pier 1, Looking North.

- (A) Reinspect the submerged substructure units at the normal maximum recommended (NBIS) interval of five (5) years.

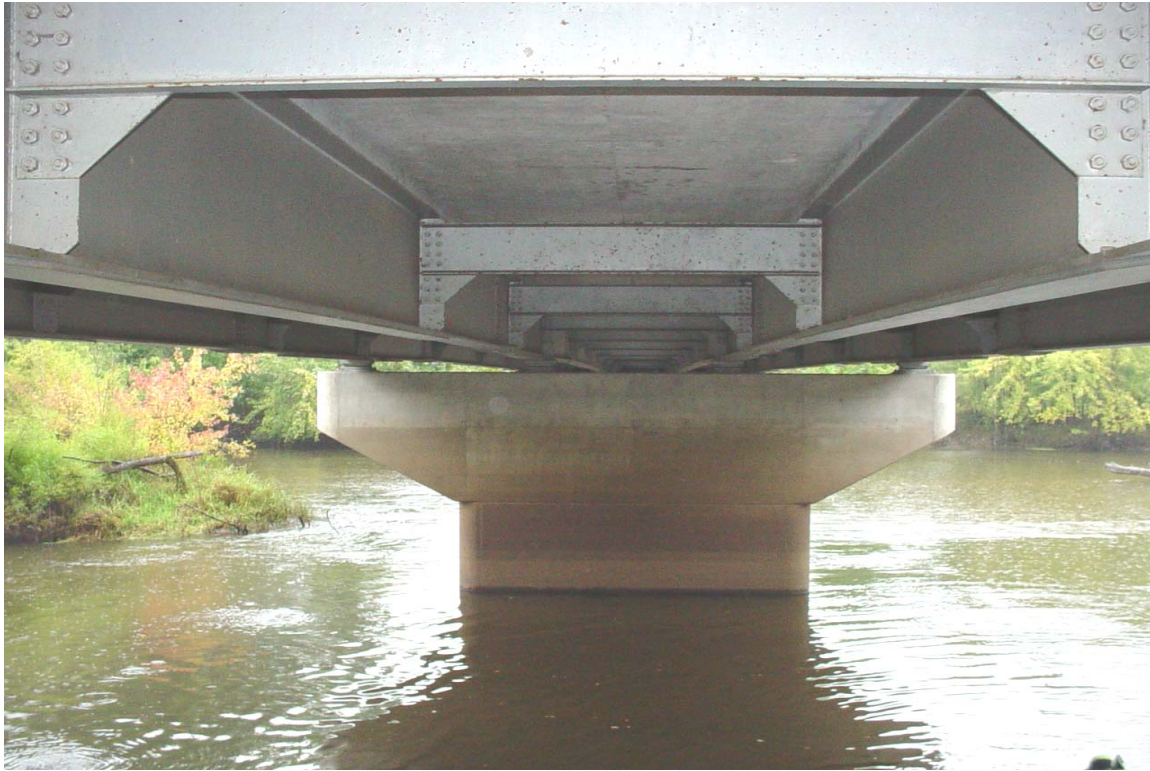
Photograph 3. View of Pier 2, Looking South.

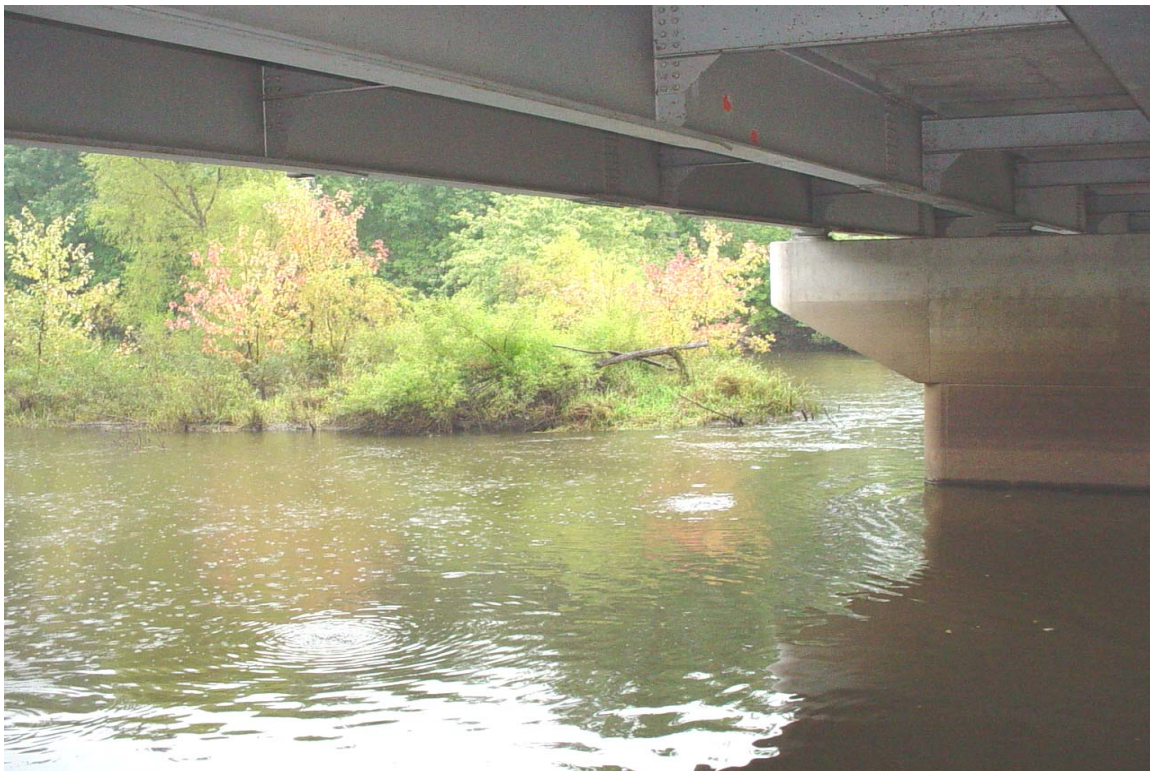
Photograph 4. View of Island in Middle of Waterway Downstream of Bridge, Looking Southeast.

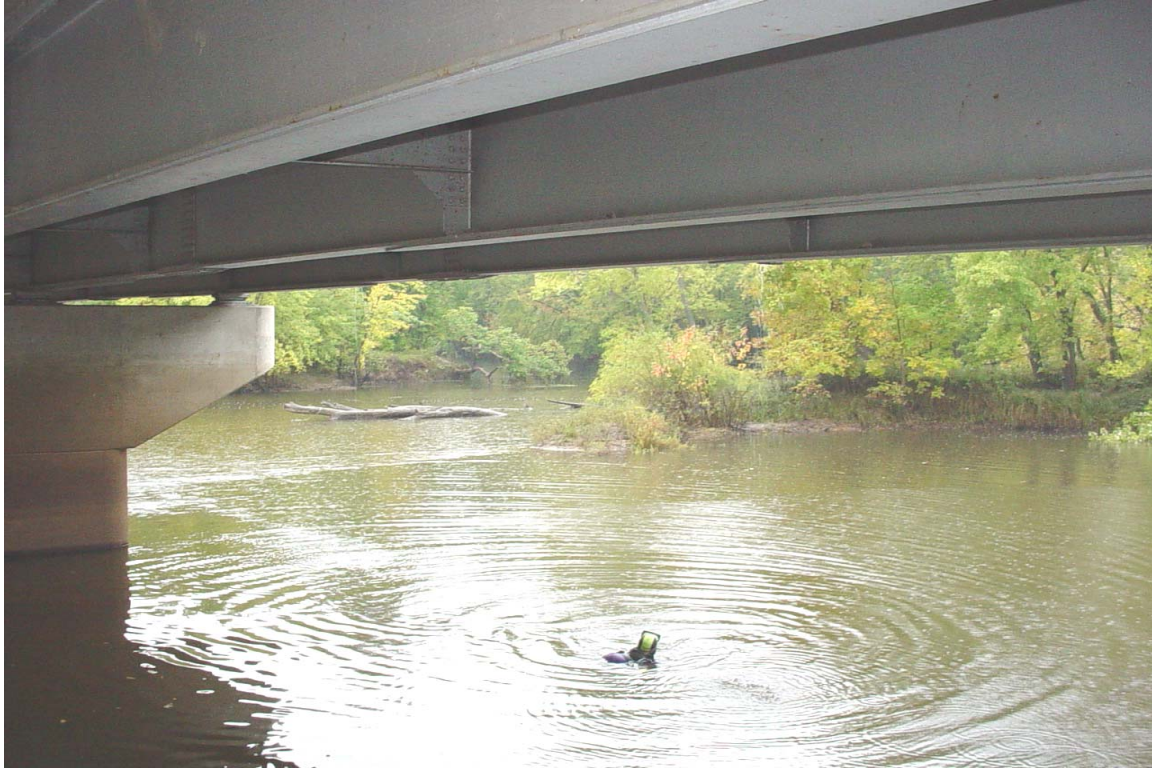
Photograph 5. View of Island in Middle of Waterway Upstream of Bridge, Looking Southwest.
